***United States Court of Appeals  
for the Second Circuit***

SEA-LAND SERVICE, INC., *et al.*,

AETNA INSURANCE COMPANY, *et al.*

**JOINT APPENDIX**

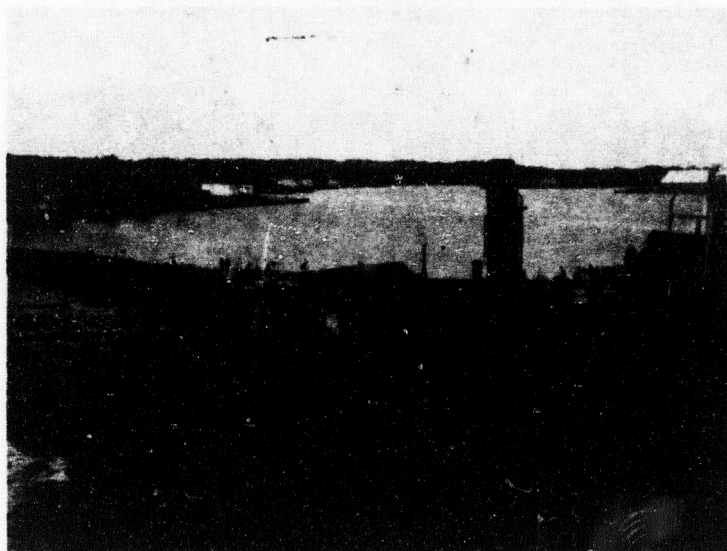
**Plaintiffs' Exhibit 2A**

[PHOTOGRAPH TAKEN FROM BEAUREGARD  
WHILE AGROUND]

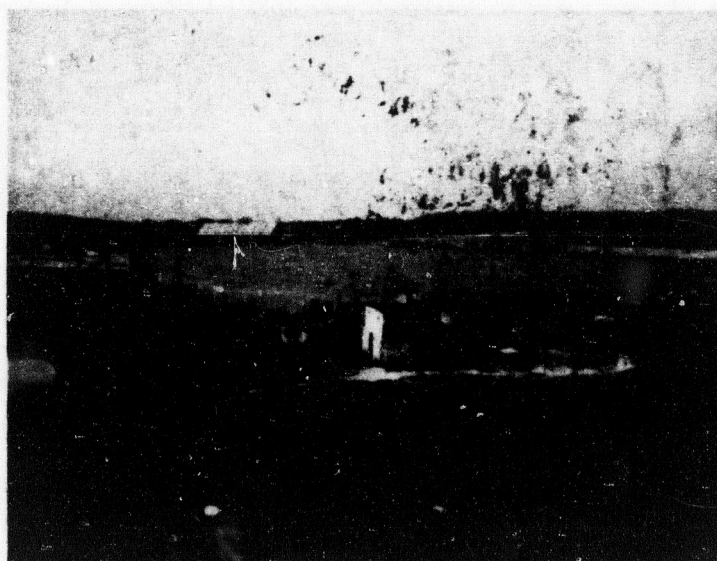
**Plaintiffs' Exhibit 2B**

[PHOTOGRAPH TAKEN FROM BEAUREGARD  
WHILE AGROUND]

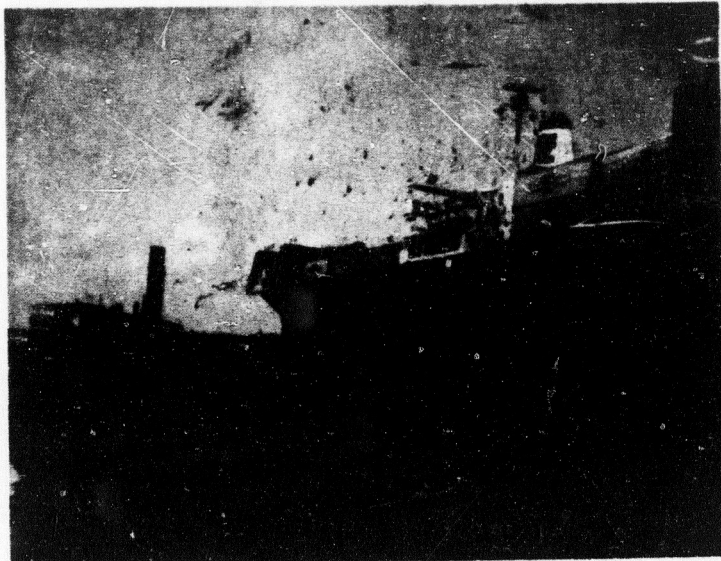
**Plaintiffs' Exhibit 2C**

[PHOTOGRAPH OF BEAUREGARD  
WHILE AGROUND]

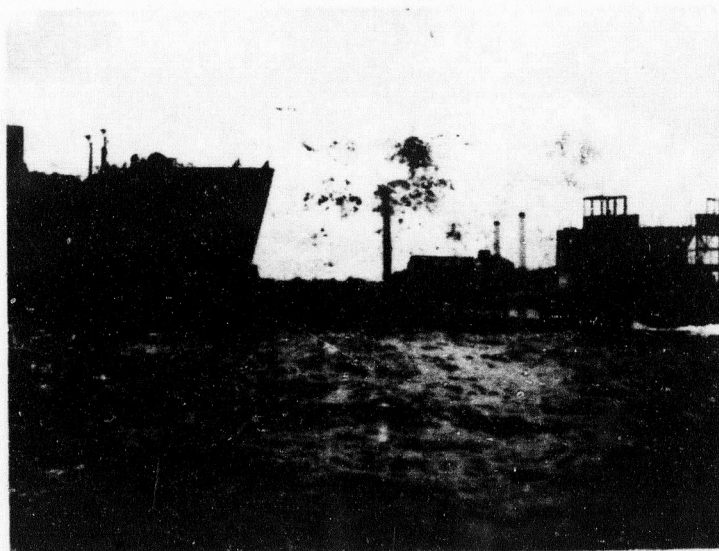
**Plaintiffs' Exhibit 2D**

[PHOTOGRAPH OF BEAUREGARD'S BOW  
WHILE AGROUND]

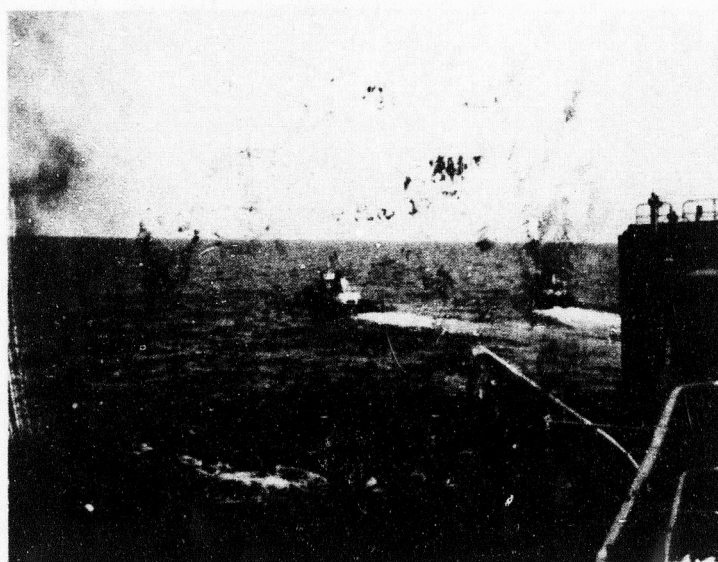
**Plaintiffs' Exhibit 2E**

[PHOTOGRAPH TAKEN FROM BEAUREGARD,  
WHILE AGROUND, OF TUGBOATS]

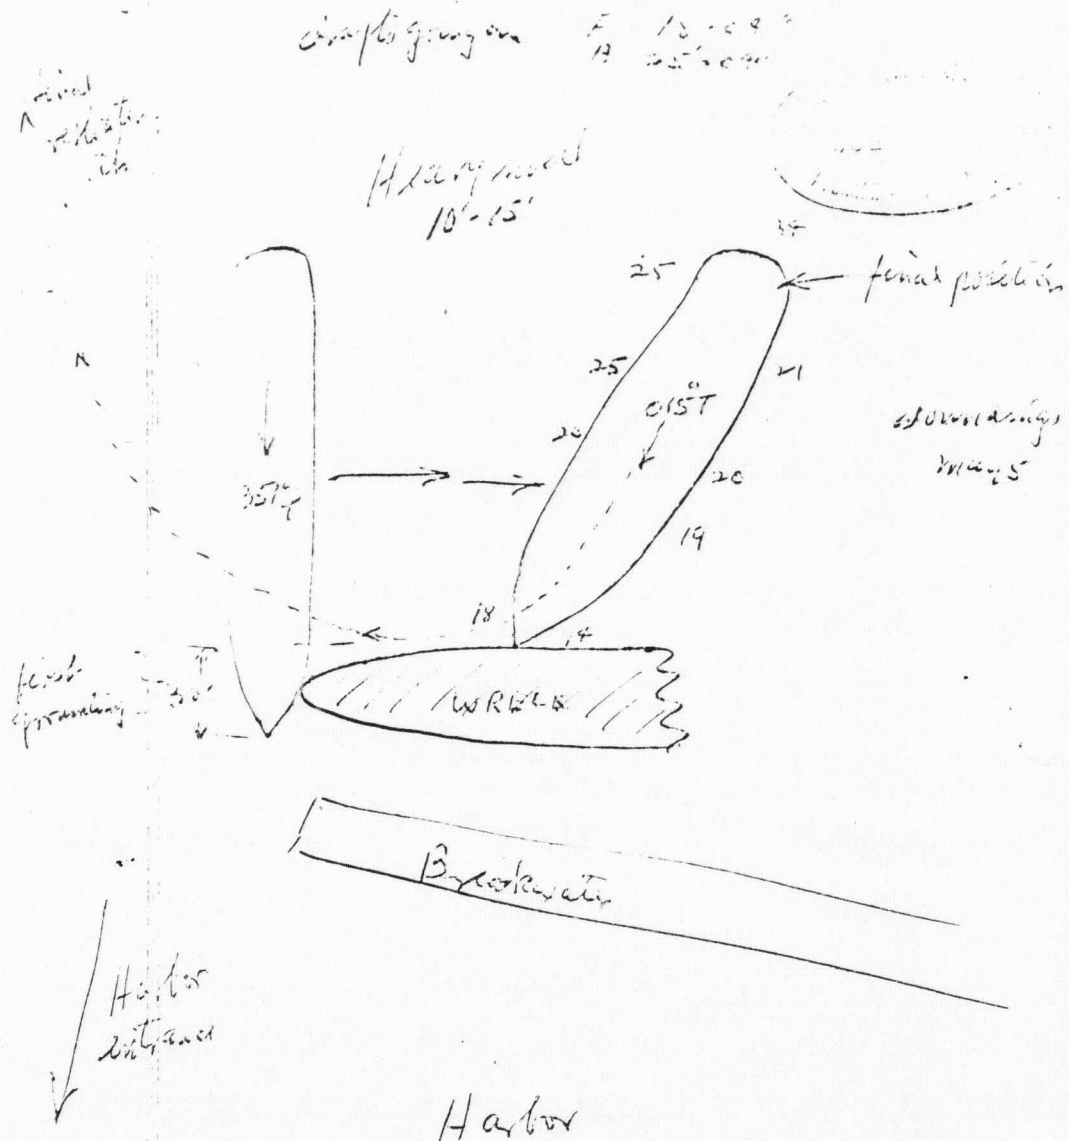
## Plaintiffs' Exhibit 13

[SKETCH OF POSITION OF VESSEL DRAWN BY MR. GANLY]

No soundings taken on first grounding - Tow broken steel grate started to back off and tow line parted backed clear but lifted ~~steel~~ further ashore in direction of arrow

For final refloating de ballasted fwd and refloated bow - then buoyed bow and tipped by bow refloating stern - (also moved vessel with cranes)

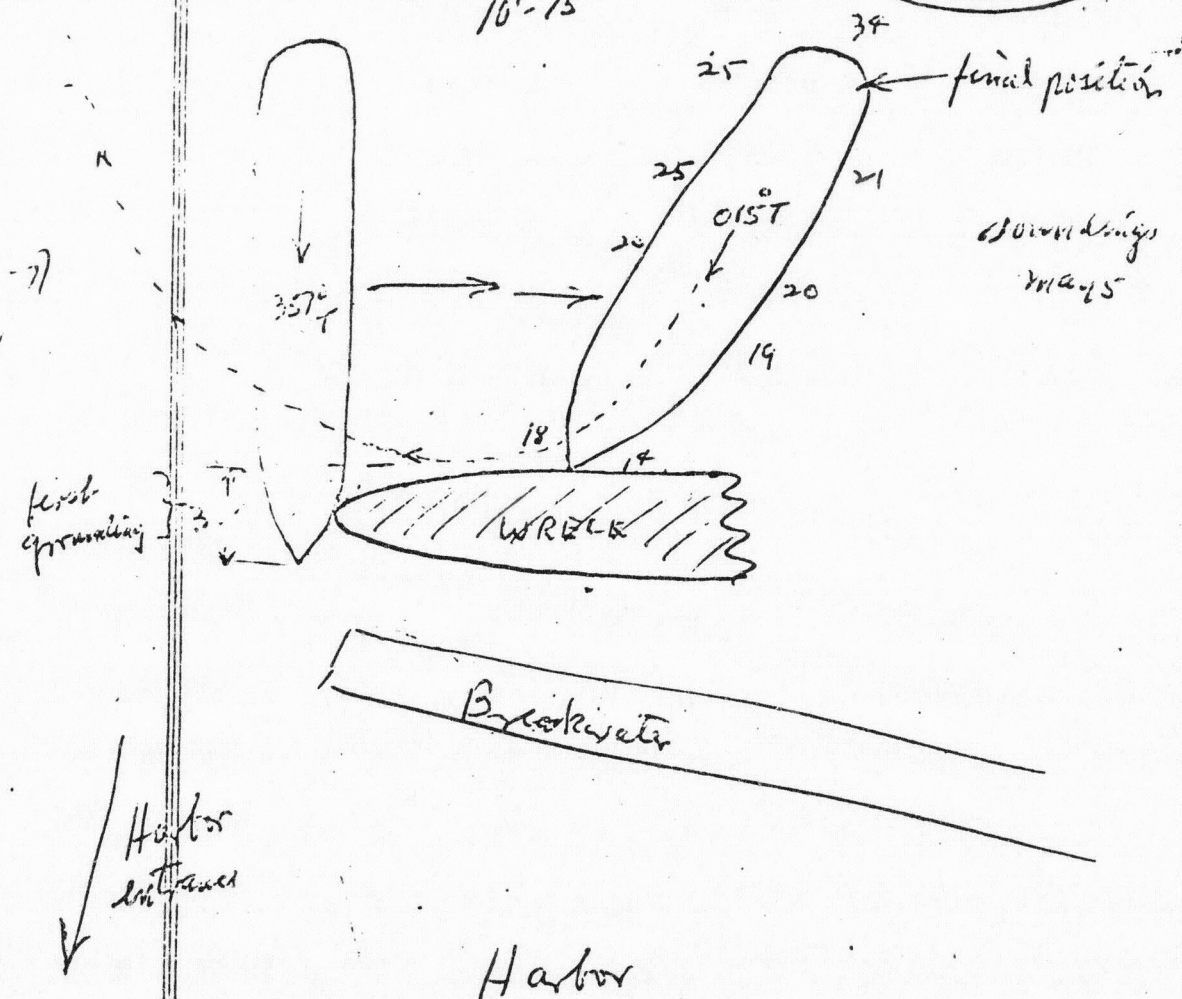
no soundings taken on first grounding - Tow barge still  
float started to back off and tow line parted. Backed clear but  
drifted ~~back~~ further ashore in direction of arrow Boat  
disappears

For final refloating de ballasted forward and floated bow -  
then ballasted bow and tipped by bow refloating stern -  
(also used vessel with cranes)
